Final Report

Assessment of Factors Limiting Salmon Production in Devil's Hole Creek

The Department of the Navy Submarine Base,
Bangor, Washington

December 2000

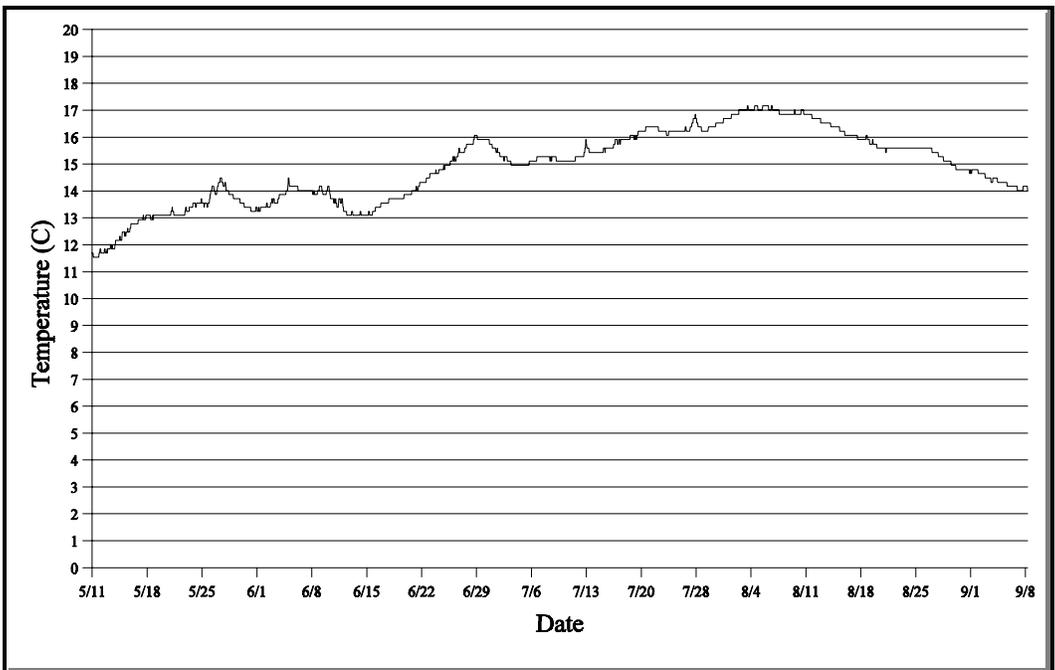
Figure 10. Summer temperature profile at 2-meters below the surface for Bangor Lake, 2000.

Temperature in Bangor Lake ranged from 11 to 17C over the summer (Figure 10). The logger's location influenced the temperatures recorded. Based on temperatures recorded during the lake survey, surface temperatures are expected to be one to two degrees higher than temperatures found at two meters. Therefore, surface temperatures in the lake may reach 19C over the summer. Devil's Hole Creek and its tributaries are classified as Class A waters. Surface temperatures should not exceed 18C in streams, nor in reservoirs with a mean detention time of 15-days or less. We estimate a mean detention time of 4-days for Bangor Lake during the summer months. The detention time would be shorter during other times of the year; therefore, the 18C temperature criteria applies to the reservoir. Although the evidence is not conclusive, it is likely that the surface layer of Bangor Lake exceeds the state temperature criteria during periods of hot summer weather. Moreover, temperatures above optimal levels for salmonids may effect growth and fitness. Spence et al. (1996) suggest temperatures above 15.6C indicate a potentially degraded condition.

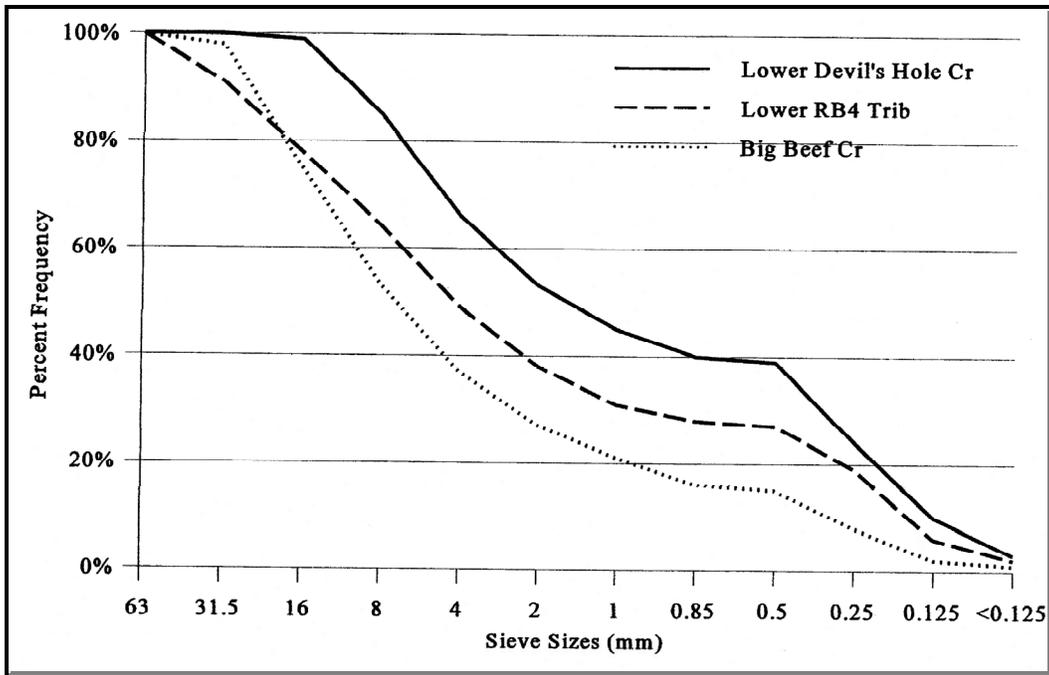
Figure 13. Average cumulative frequency distribution of sediment size categories found in samples from Devil's Hole Creek, RB4 tributary of Devil's Hole Creek, and Big Beef Creek, 1999.

Sample analysis showed that samples taken from Devil's Hole Creek and RB4 had a much larger fraction of smaller size sediments than did Big Beef Creek (Figure 13). Excess fine sediments, grain sizes of less than 0.85-mm diameter, are considered deleterious to incubating salmon eggs. They fill the interstitial spaces between the larger gravels, preventing the flow of water and oxygen to the eggs, causing the eggs to suffocate (Spence et al., 1996). Sand and fine sediment can also act as a physical barrier to fry emergence and inhibit the removal of metabolic waste from the egg pocket (Koski 1975). Fine sediments in the five processed Devil's Hole samples averaged 39% and ranged from 30% to 55% (Table 6). Fine sediment from the three samples taken from RB4 averaged 27%. By comparison, those taken from Big Beef Creek averaged 15%.

Examination of surficial sediments for each reach indicated a high level of sand throughout the Devil's Hole watershed. Sand was estimated to comprise 20 to 90% of the bed substrate found in each reach. The best substrates found for spawning occurred in RB2, between 100 and 200-meters upstream from its confluence with Devil's Hole Creek; and RB4, over the first 200-meters upstream from the Sturgeon Street/Snook Road culvert. Both these areas combined a relatively low level of sand (<30%) with a high level of cobble or gravel and channel gradients of around 2%. There were other sites with relatively good spawning gravel, but channel gradients at those sites were over 3%, which is steeper than preferred by most salmonids.

While the high level of sand and fine sediments found in the Devil's Hole watershed samples undoubtedly have a negative impact on egg-to-fry survival, researchers have had a difficult time agreeing on the level of impact that results from these conditions. Egg-to-fry survival is highly variable relative to substrate size distribution. For example, Koski (1975) found a negative relationship between the percentage of sand and fine sediments in spawning habitat and egg-to-fry survival for chum salmon in Big Beef Creek. His regression equation predicts an average chum egg-to-fry survival of 12%, 32%, and 44% for Devil's Hole Creek, RB4, and Big Beef Creek, respectively using our substrate data. These survival rates may be somewhat optimistic for the Devil's Hole watershed. McHenry et al., (1994) measured egg-to-fry survival of coho and steelhead in Strait of Juan de Fuca streams and found less than 12% survival when fine sediments

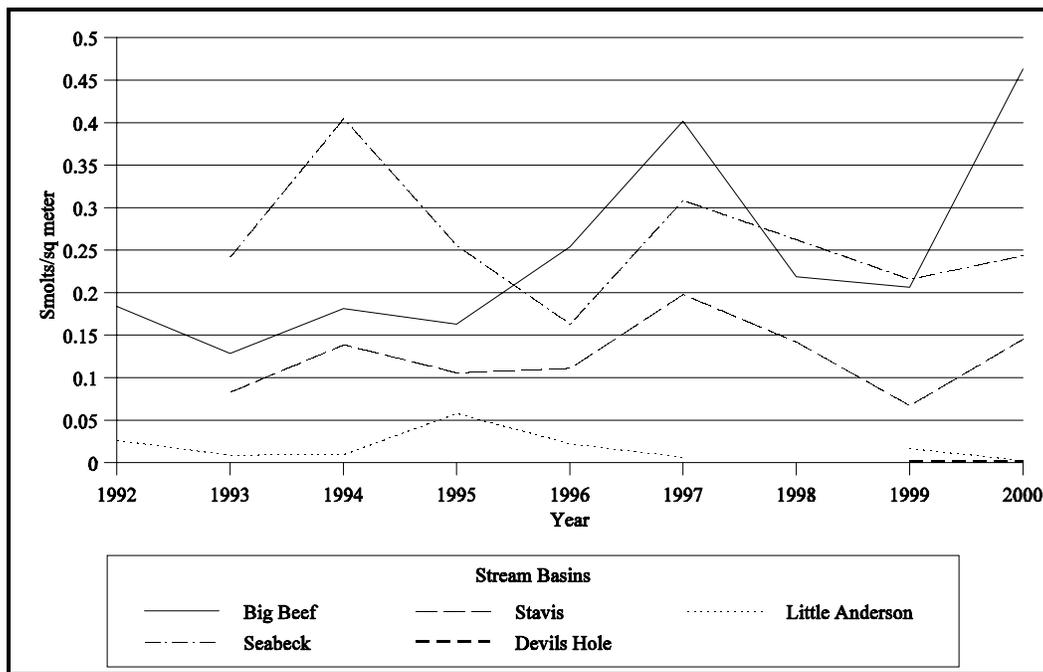
Figure 17. Comparison of the annual coho production rate between Hood Canal streams.

Salmonid freshwater production from the Devil's Hole watershed occurs at very low levels relative to other streams in the area (Figure 17). Production from other nearby streams trapped in 1999 and 2000 averaged 0.01 to 0.33 coho smolts produced per square meter of wetted habitat. Production from the Devil's Hole watershed was 0.002 coho smolts per square meter; or about 1/5th the production from the next poorest producing stream. This section describes the conditions in Devil's Hole Creek that we believe contribute to this very low production level.
